DOT HS 811 764

May 2013

Tire Oven-Aging Test and Roadwheel Testing to Failure: Tire Aging Phase 3 Research

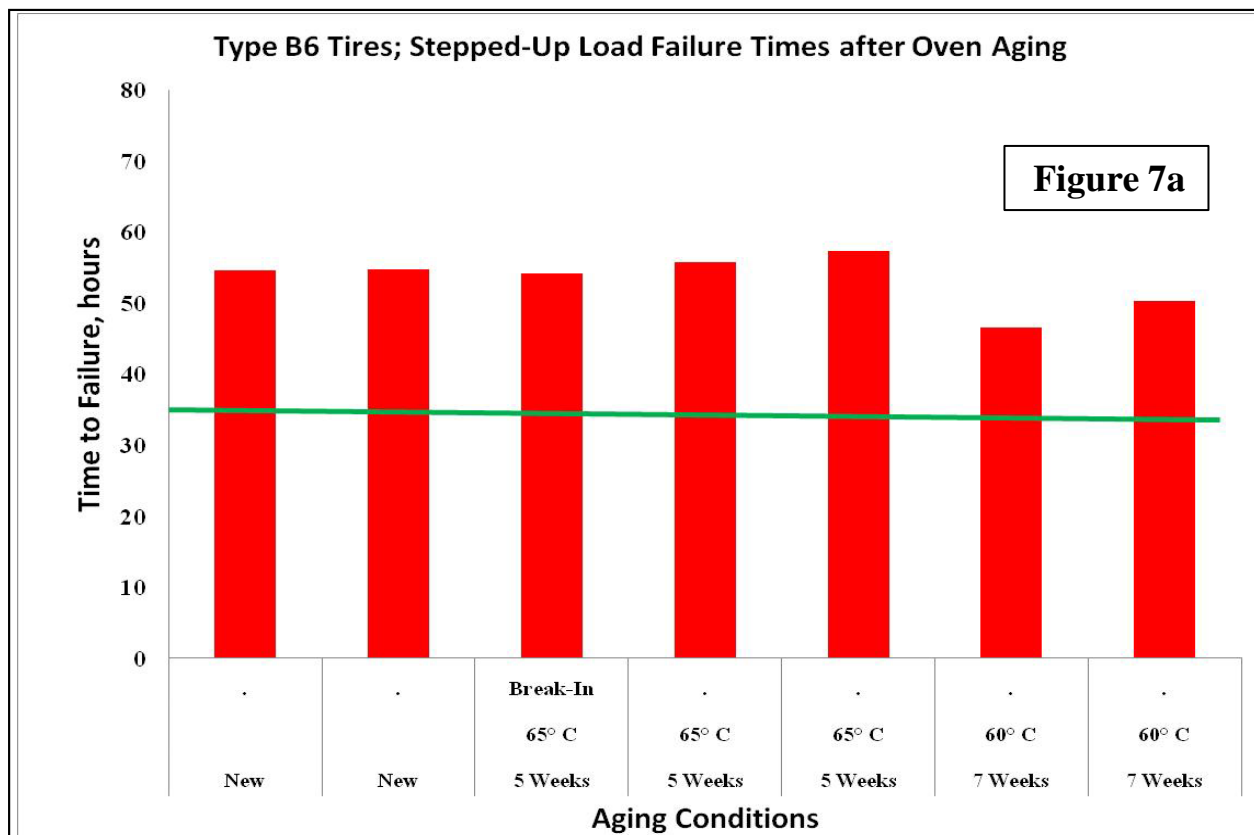
Figure 7, charts a to l which follow contain the roadwheel time-to-failure data for each passenger tire model as new and after oven aging at various conditions. While all of the new tires exhibited failure times beyond 34 hours (shown by the horizontal green line), for the aged tires approximately half of the models ran beyond the 34 hour test time, and the rest failed in times ranging from less than 4 hours to over 30 hours.

Figure 7. Passenger Tires Tested by Stepped-up-load, New and After Oven Aging

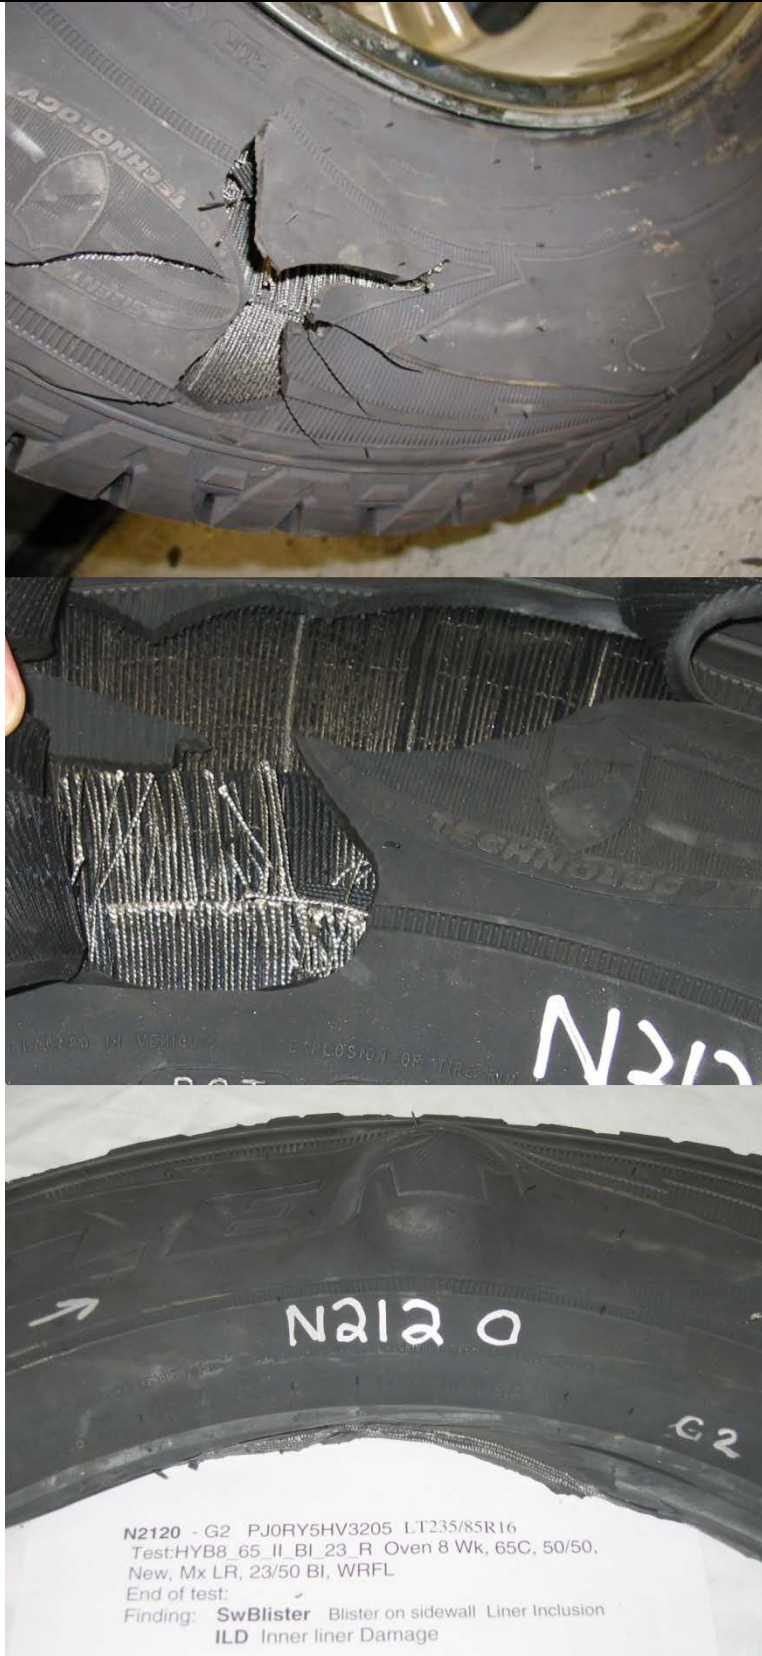
N2122 – G2 PJ0RY5HV3305 LT235/85R16

Finding: SwBlister: Blister on sidewall, PCD-TC: Ply Coat Delamination To Cords
Perforated liner found where sidewall blowout occurred. Separation of turn-up to body ply and sidewall and loss of adhesion to the cords. Skim rubber removed from the body cords.

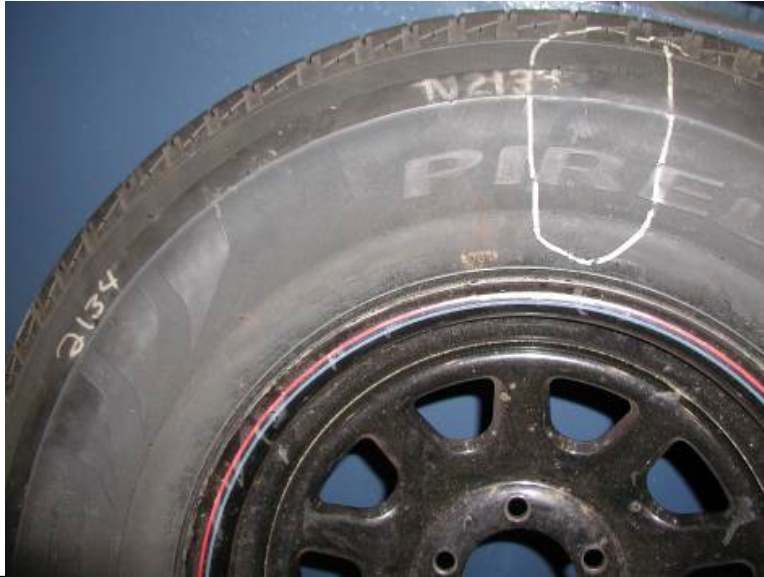
Finding: SwBlister: Blister on sidewall

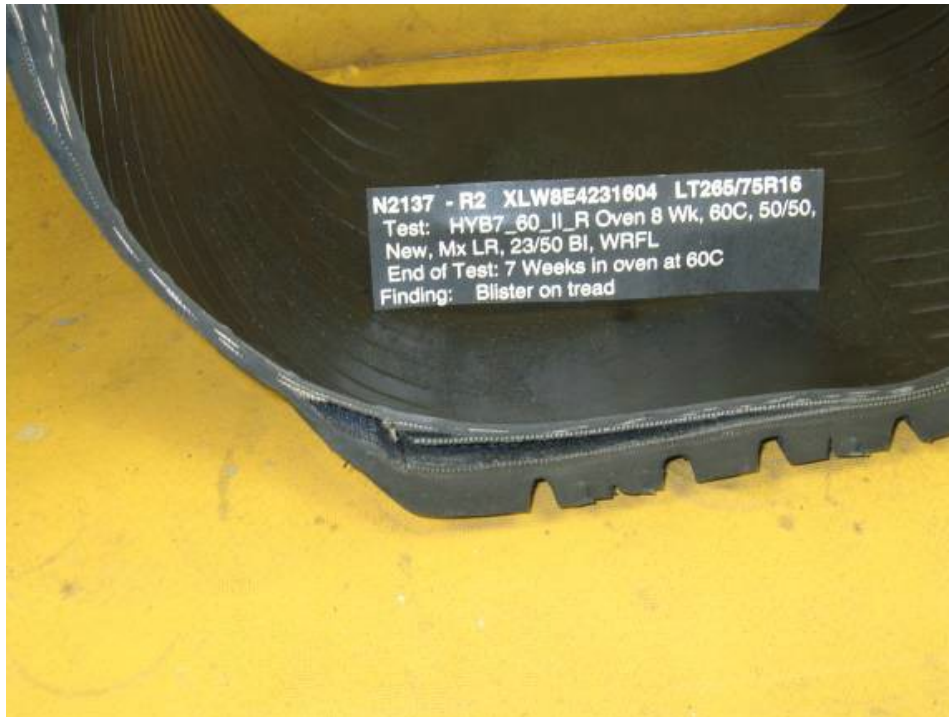
N2208 - B4 ENLFDAC5204 LT285/75R16

Finding: Blister on tread

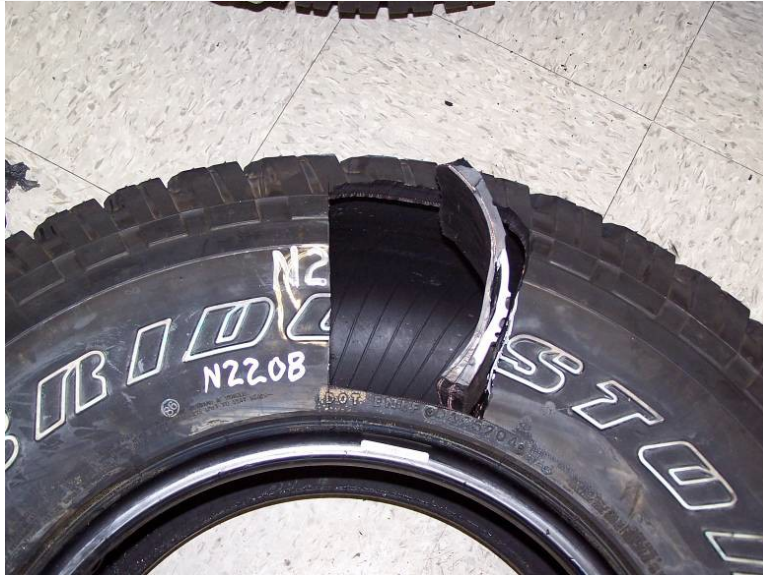
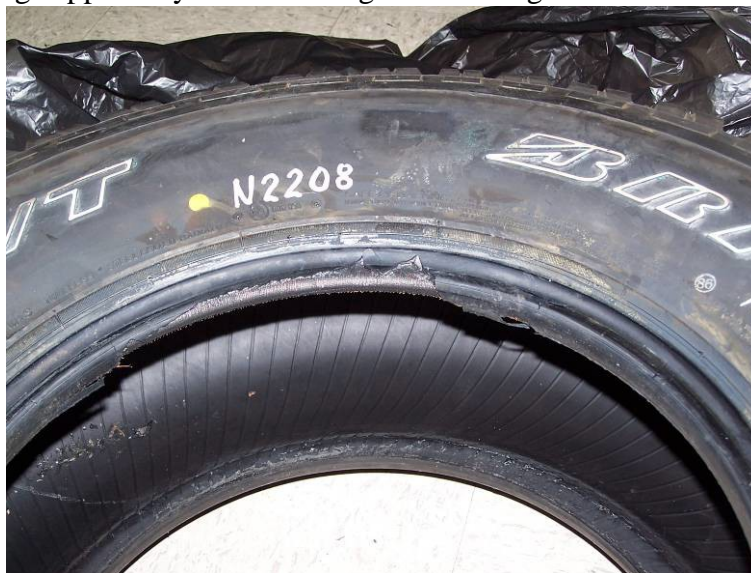
Finding: PCD- SwBlister Blister on sidewall OSS White sidewall

Sidewall separations between the turn-up and filler and turn-up and white sidewall.

Some slight inclusions were found in the liner, but no perforation was found. Bead area had damage apparently caused during dismounting.

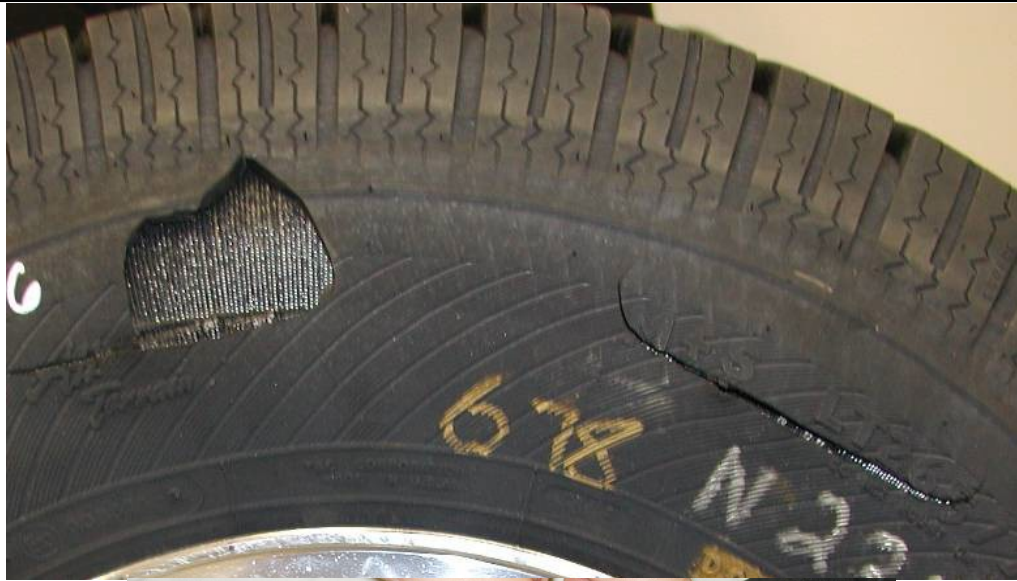
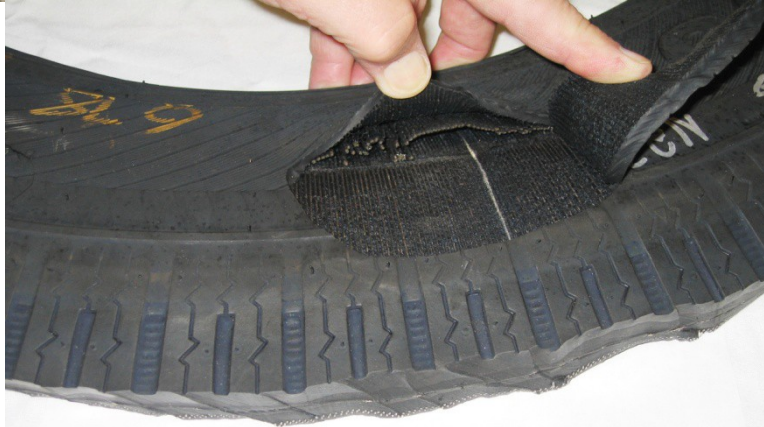
Finding: PCD-I Ply Coat Delamination Interface SS

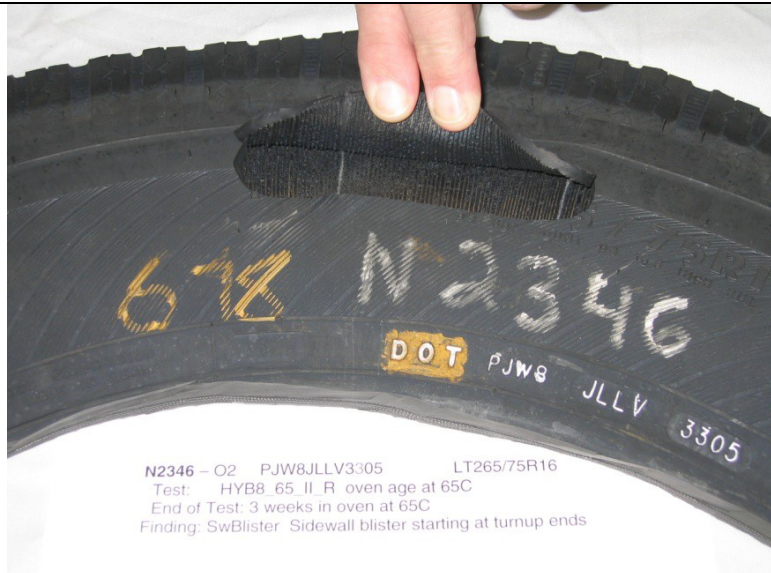
N2346 - O2 PJW8JLLV3305 LT265/75R16
 Test: HYBB 65 II_R oven age at 65C
 End of Test: 3 weeks in oven at 65C
 Finding: SwBlister Sidewall blister starting at turnup ends

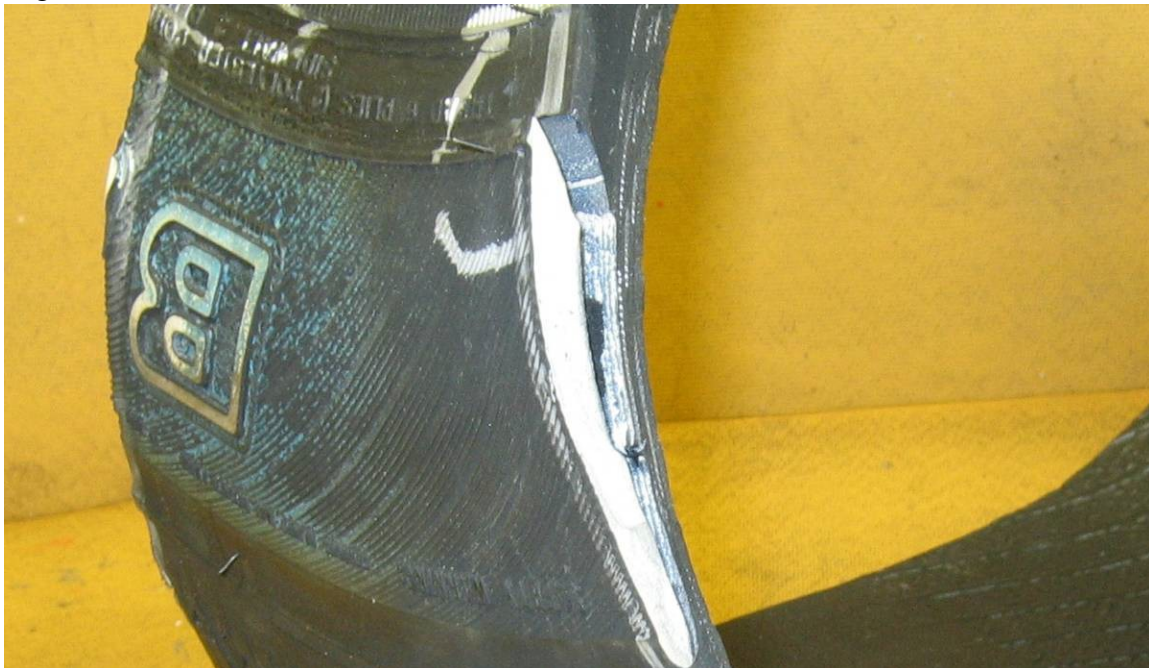
Finding: Cracks in Bead Filler

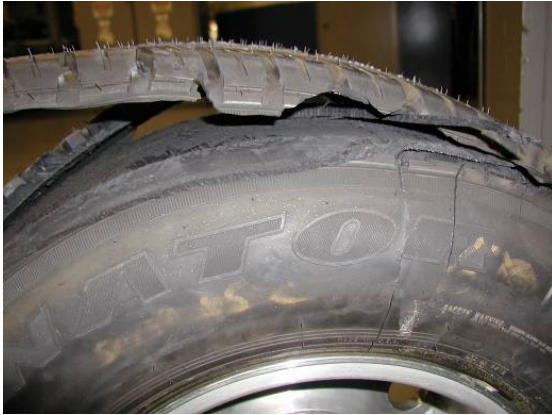
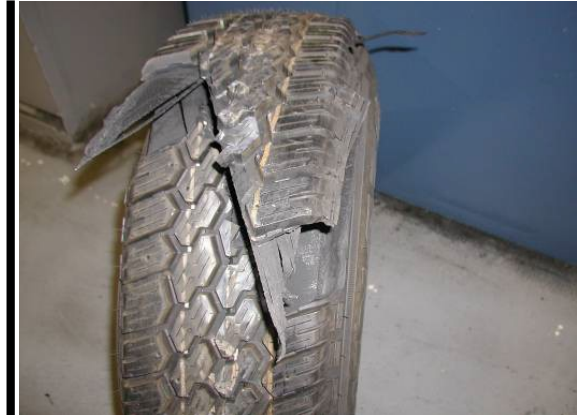
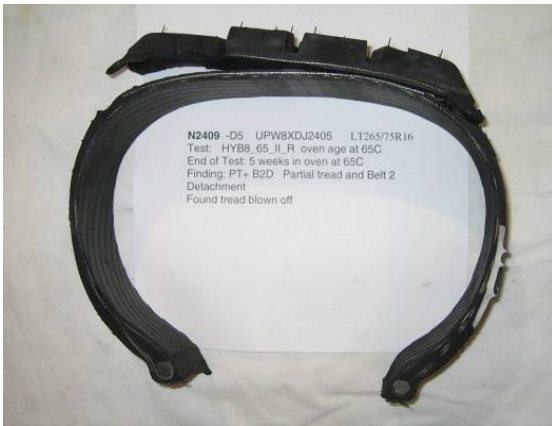
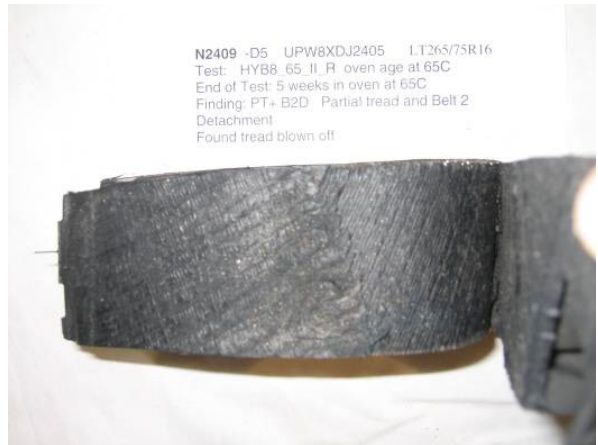
Finding: PT+B2D: Partial tread and Belt 2 Detachment
Found tread partially blown off in oven.

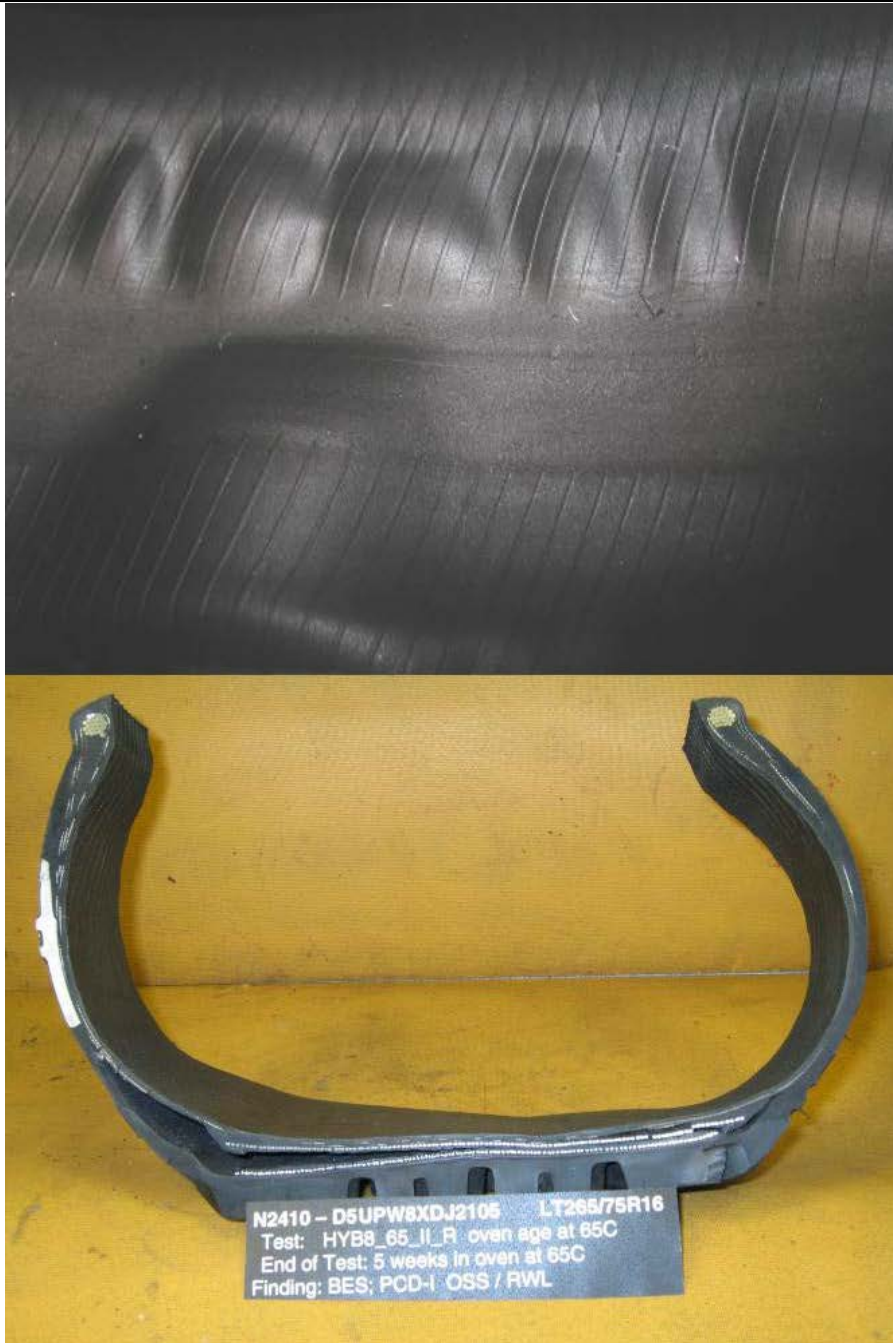
Finding: BES; PCD-I OSS / RWL

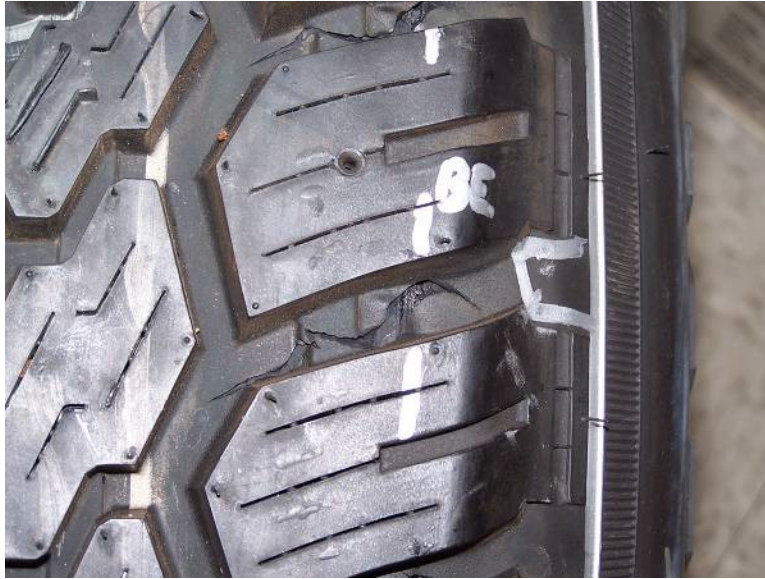
Finding: TGCr, B1P1D, BBS

Tire was found with what appeared to be large liner separation which appears to have allowed air to flow to the belt edges and cause severe cracking at the belt edges.

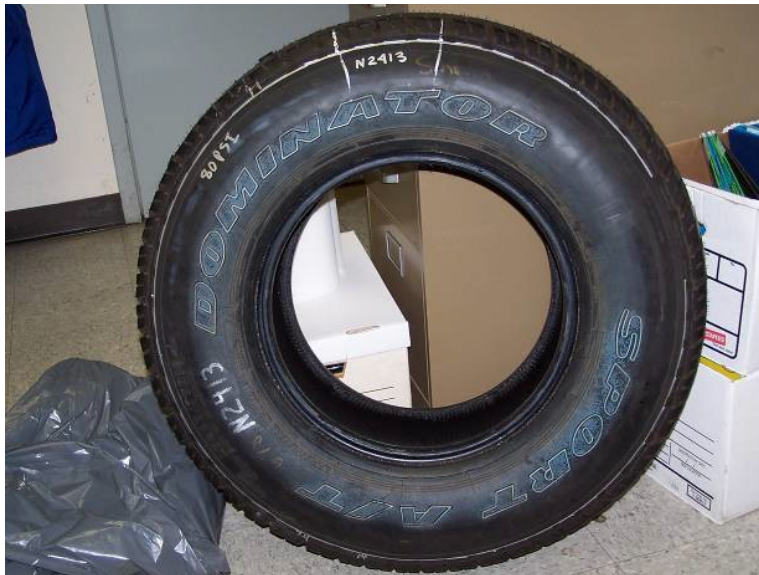
TGCr - Tread Groove Cracking

OSS side of tire has cracks nearly 340 to 350 degrees (see area highlighted with white line).
